# **Inventory of Current Conditions and Land Uses**

## **Red Rock Road, Douglas County**

**Oregon Department of Environmental Quality  
and  
The Weyerhaeuser Company**

**June 2008**

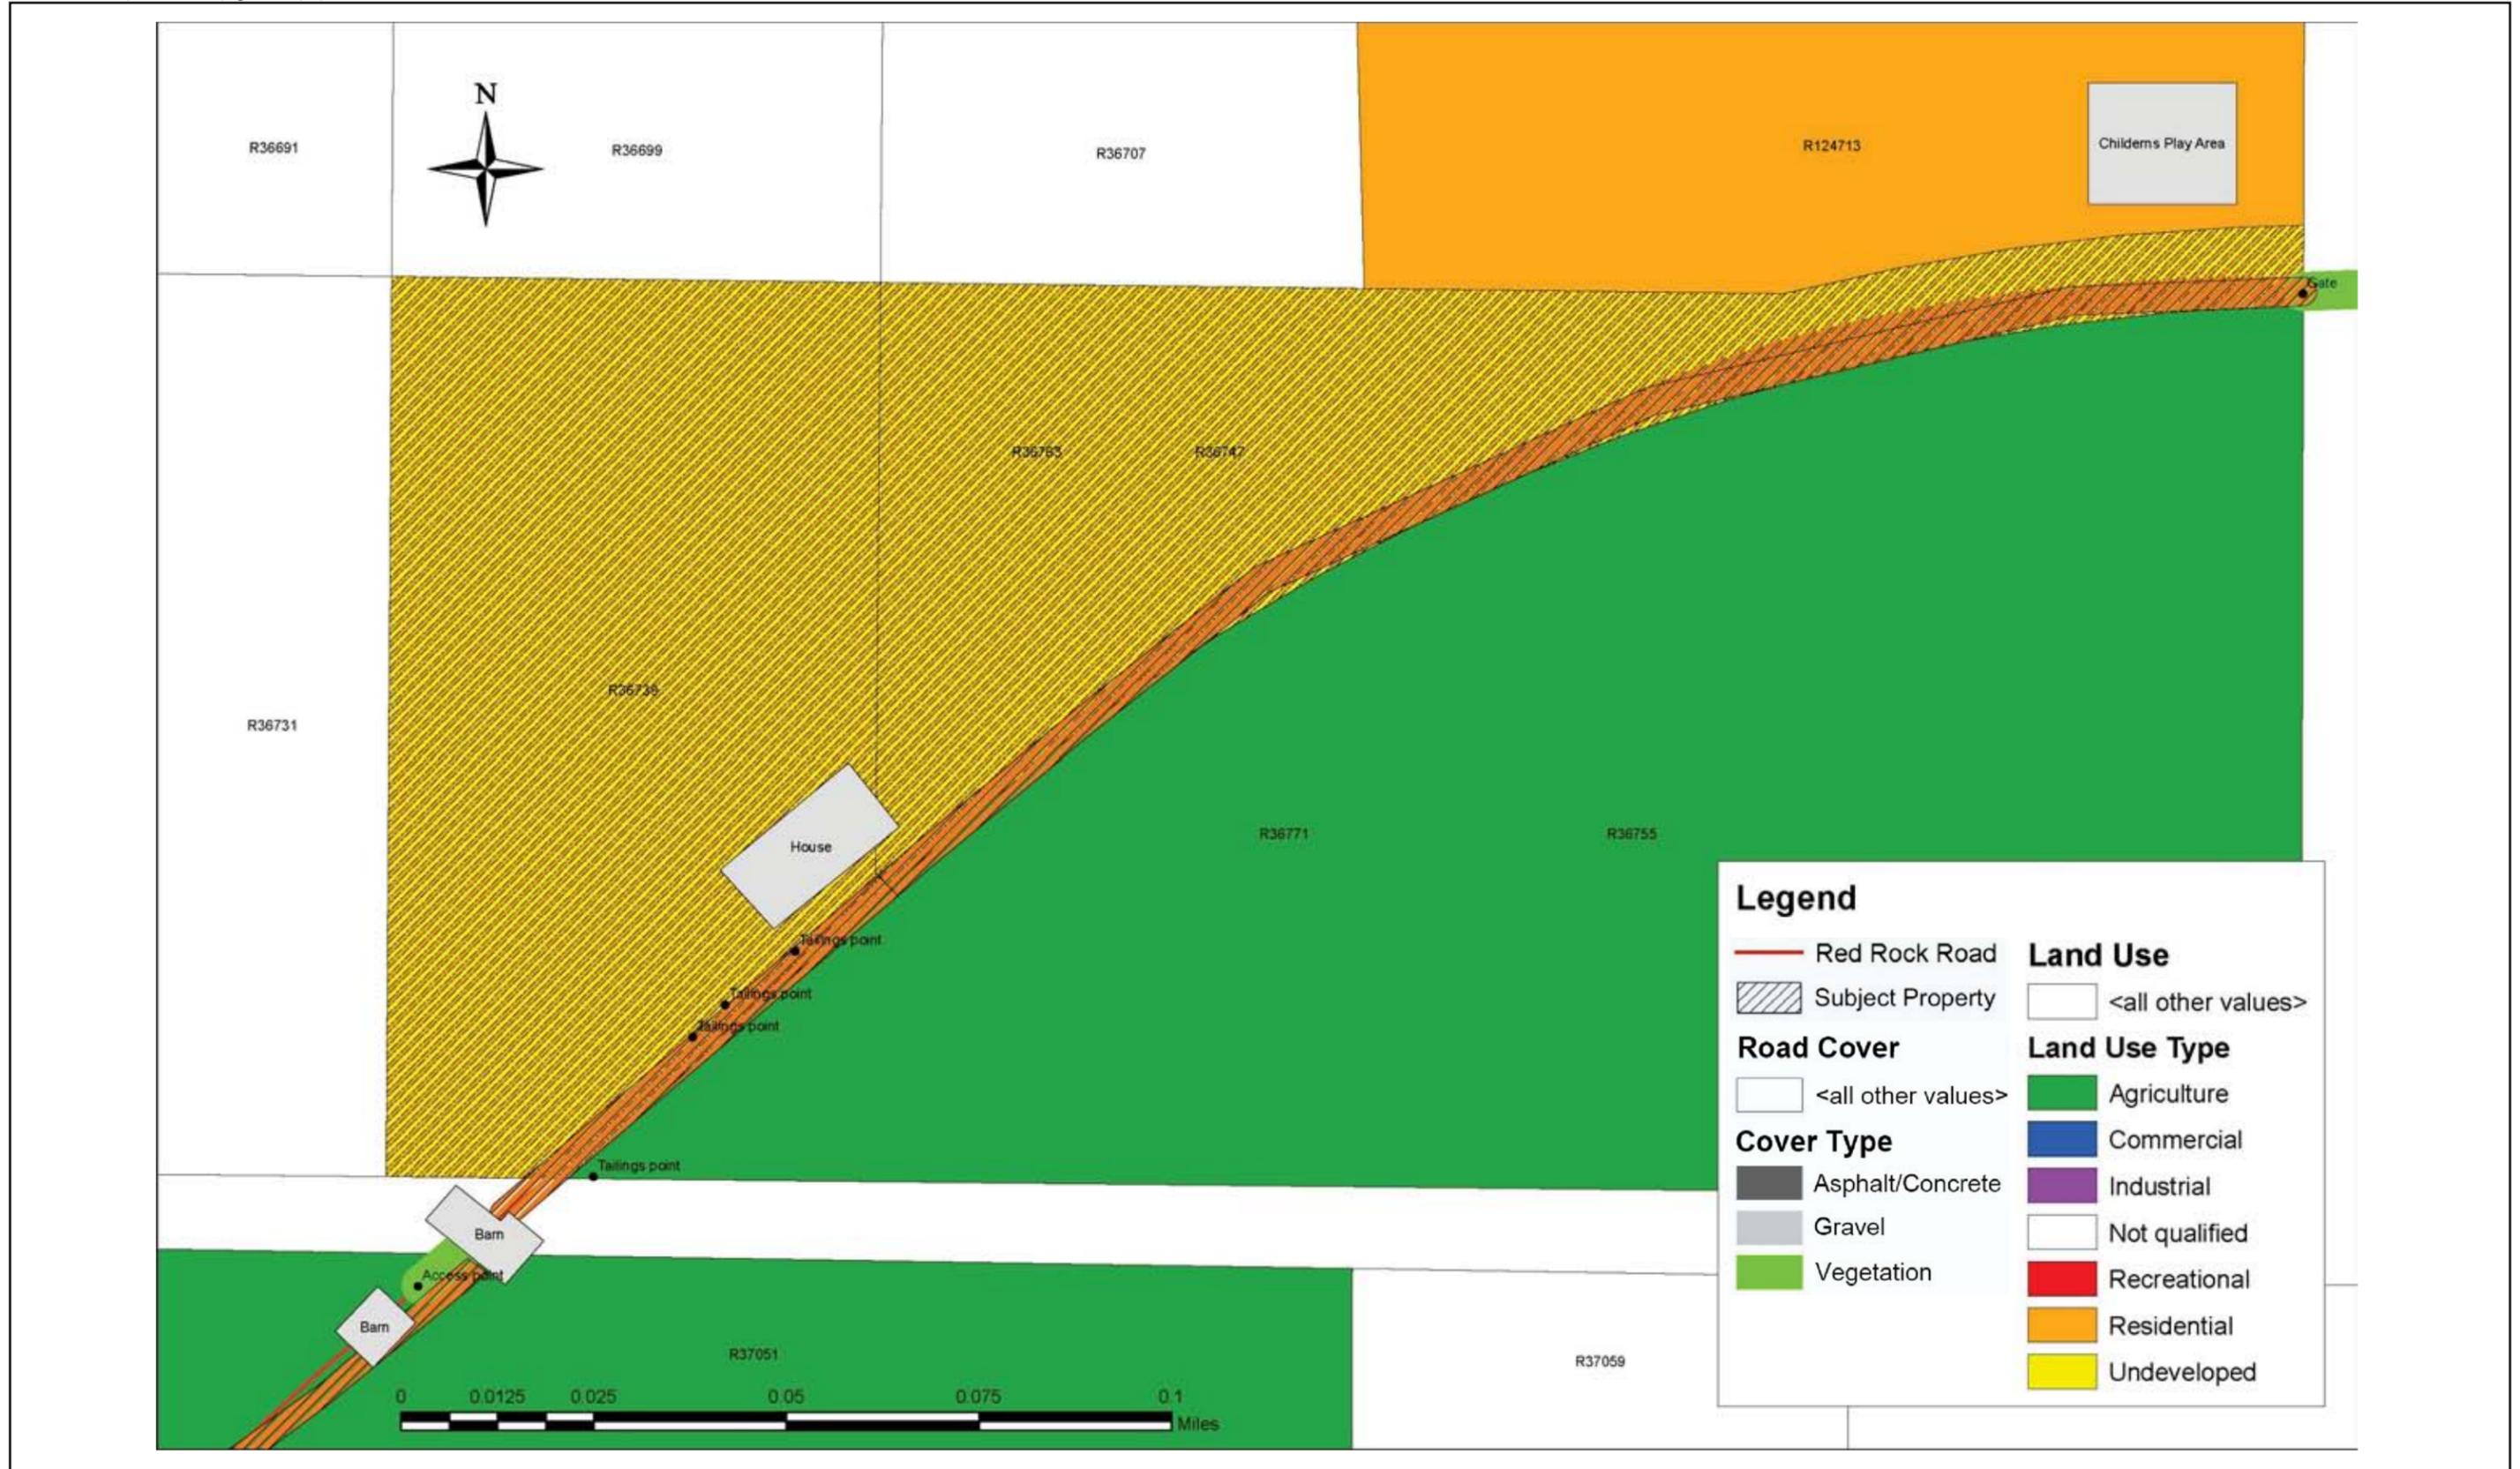
**Figure 4**  
**Map of Property #1**  
**Parcel R36736 and R36747**

Parcels R36739 and R36747 (Figure 4) are west of Plat B Road. Red Rock Road extends from the southwest to the northeast on the southern property boundary. Two structures are located on this property, including 1) a barn in the southwestern corner, directly on top of RRR, and 2) a residence approximately 300 feet to the northeast and directly adjacent to RRR.

Red Rock Road is used as the driveway to the residence and barn. It is covered with packed gravel, and tailings can be seen in potholes. Some reworking of the original RRR alignment appears to have occurred near the barn. Children's toys can be seen along RRR near the barn. To the north of parcels R36739 and R36747 is property R124713, where a children's play area is less than 100 feet from RRR.

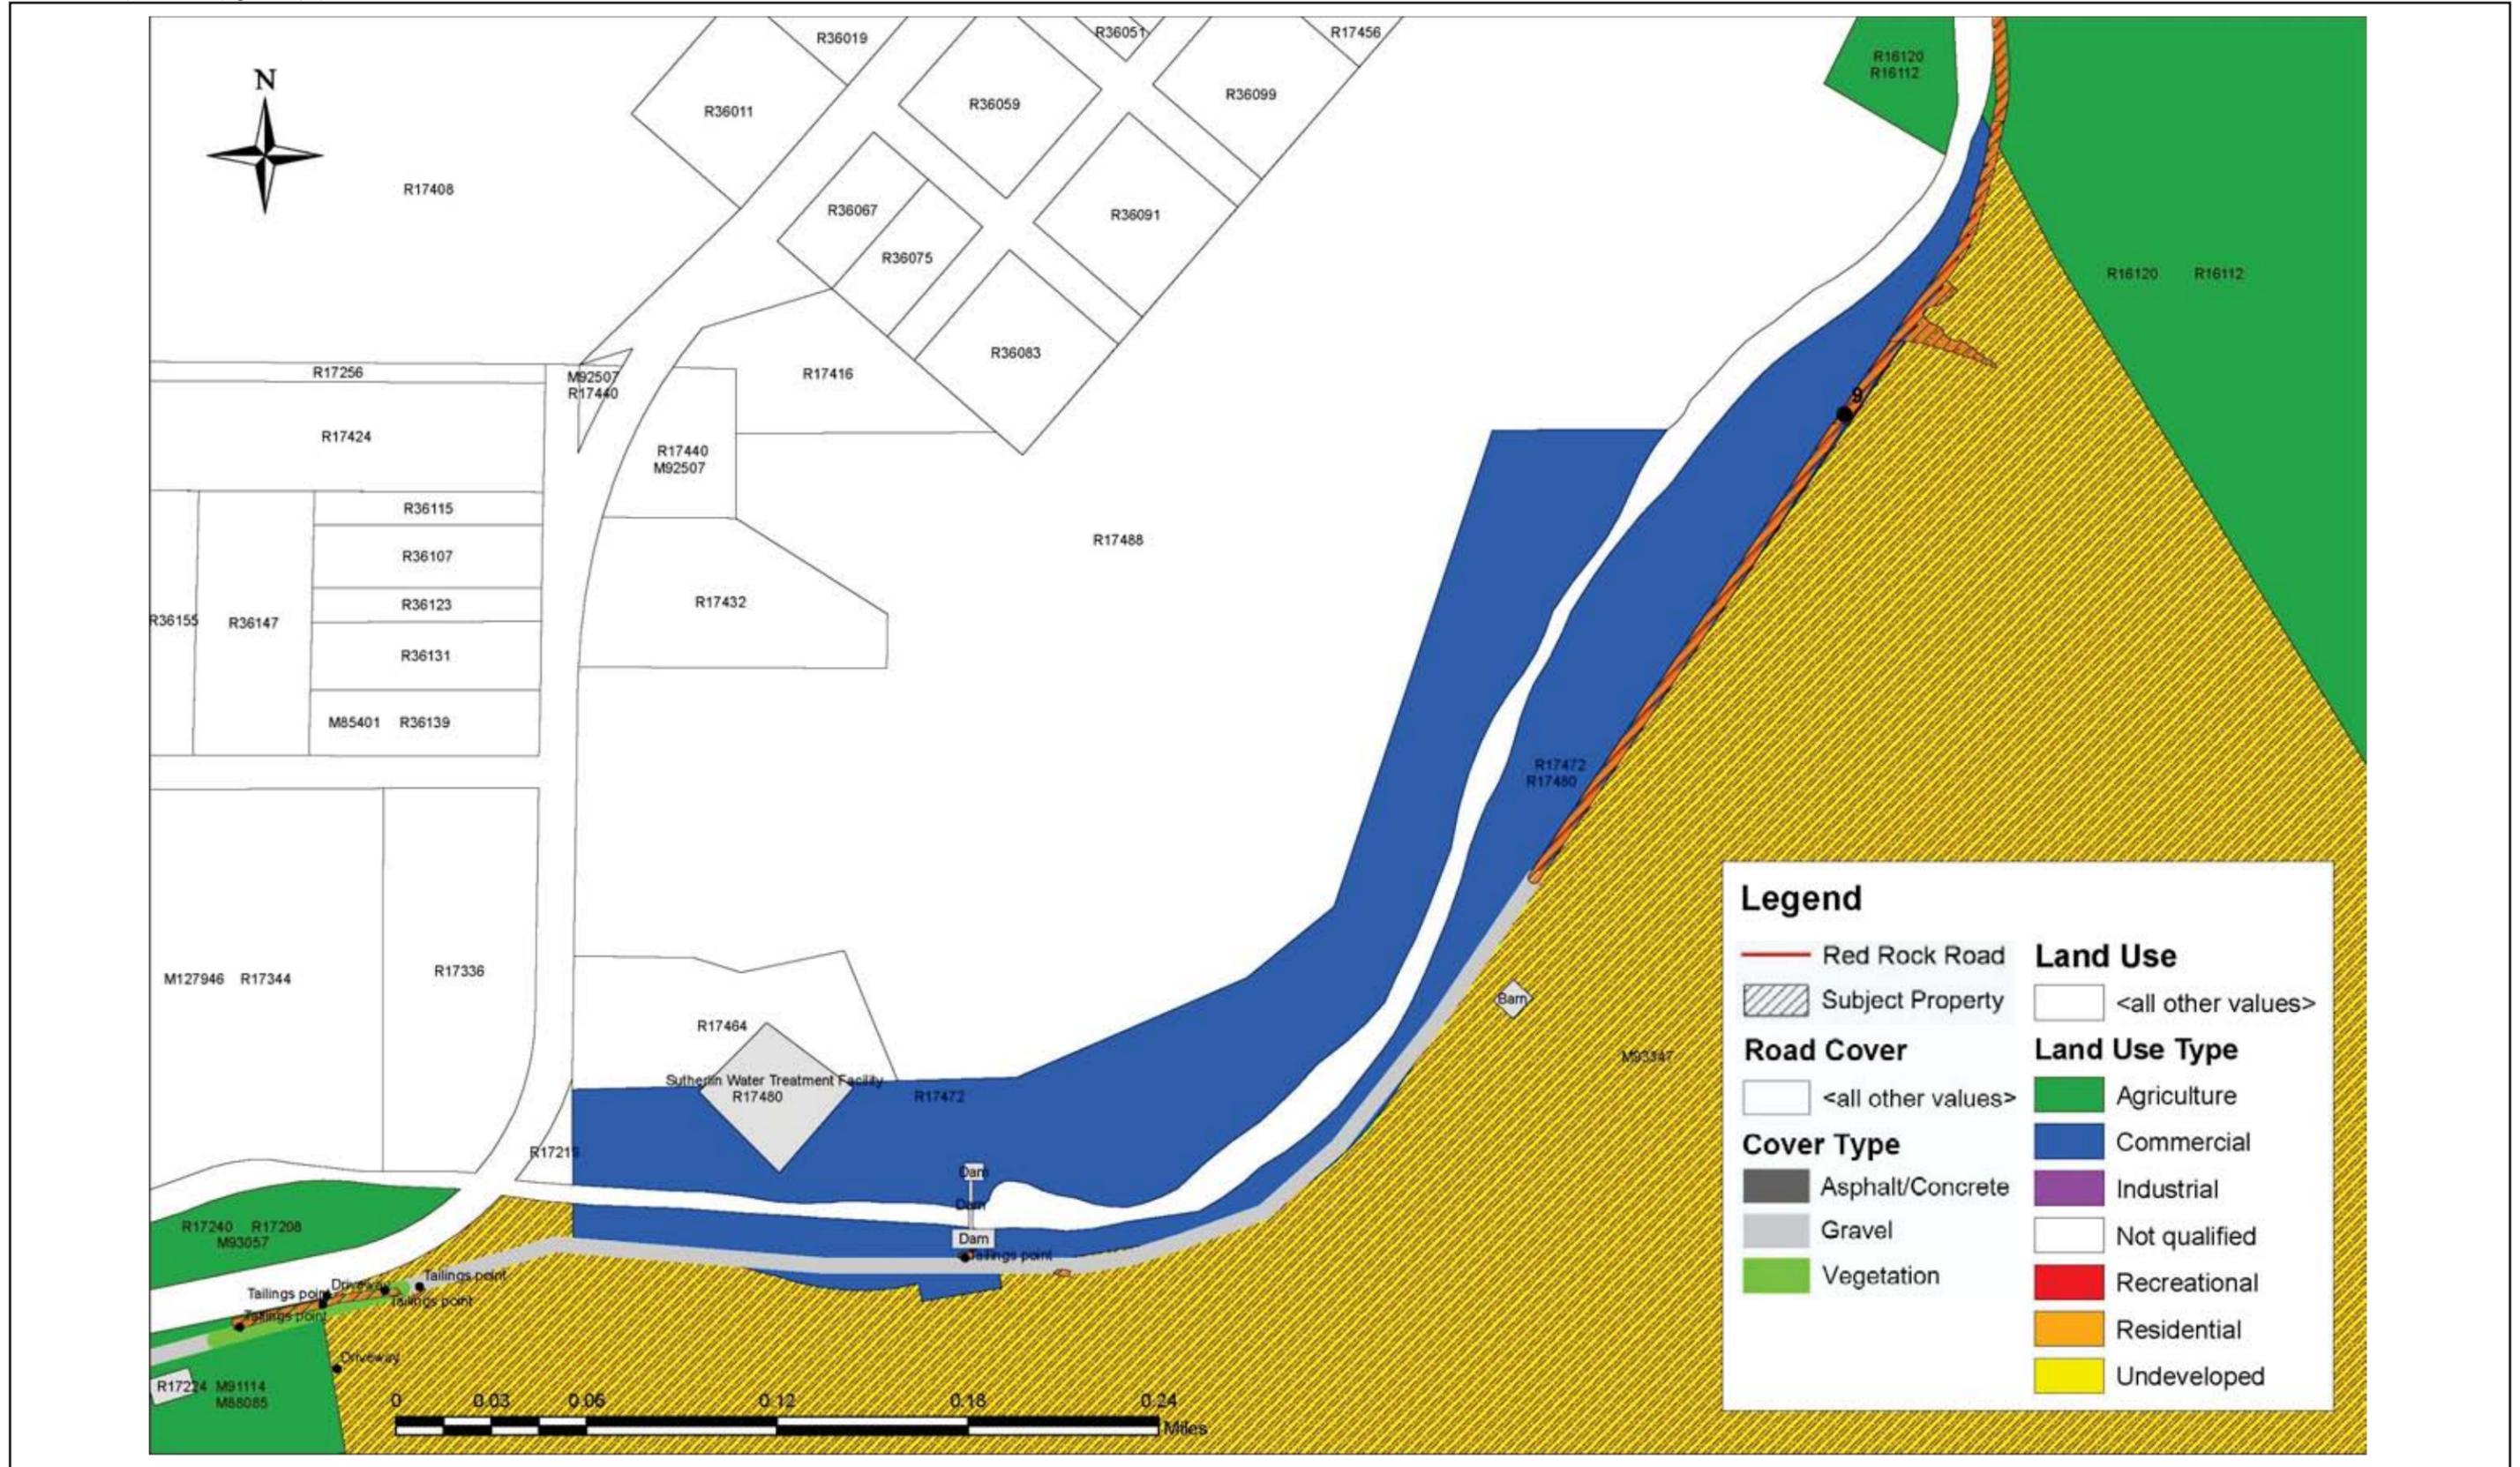
**Figure 5**  
**Map of Property #2**  
**Parcel R17504**

Parcel R17504 is south of Nonpareil Road 8.5 miles east of Sutherlin (Figure 5). Red Rock Road extends along the northern edge of the property from west to northeast paralleling Calapooya Creek. The property is used for cattle grazing and for access by the City of Sutherlin to a dam on Calapooya Creek. The only structures on the property are a barn and corral.

Red Rock Road is used as a driveway to access the residence to the south. A 0.25-mile-long section of RRR is uncovered and tailings are visible for its entire length. Sections of RRR are also covered with gravel, but tailings are visible in potholes.

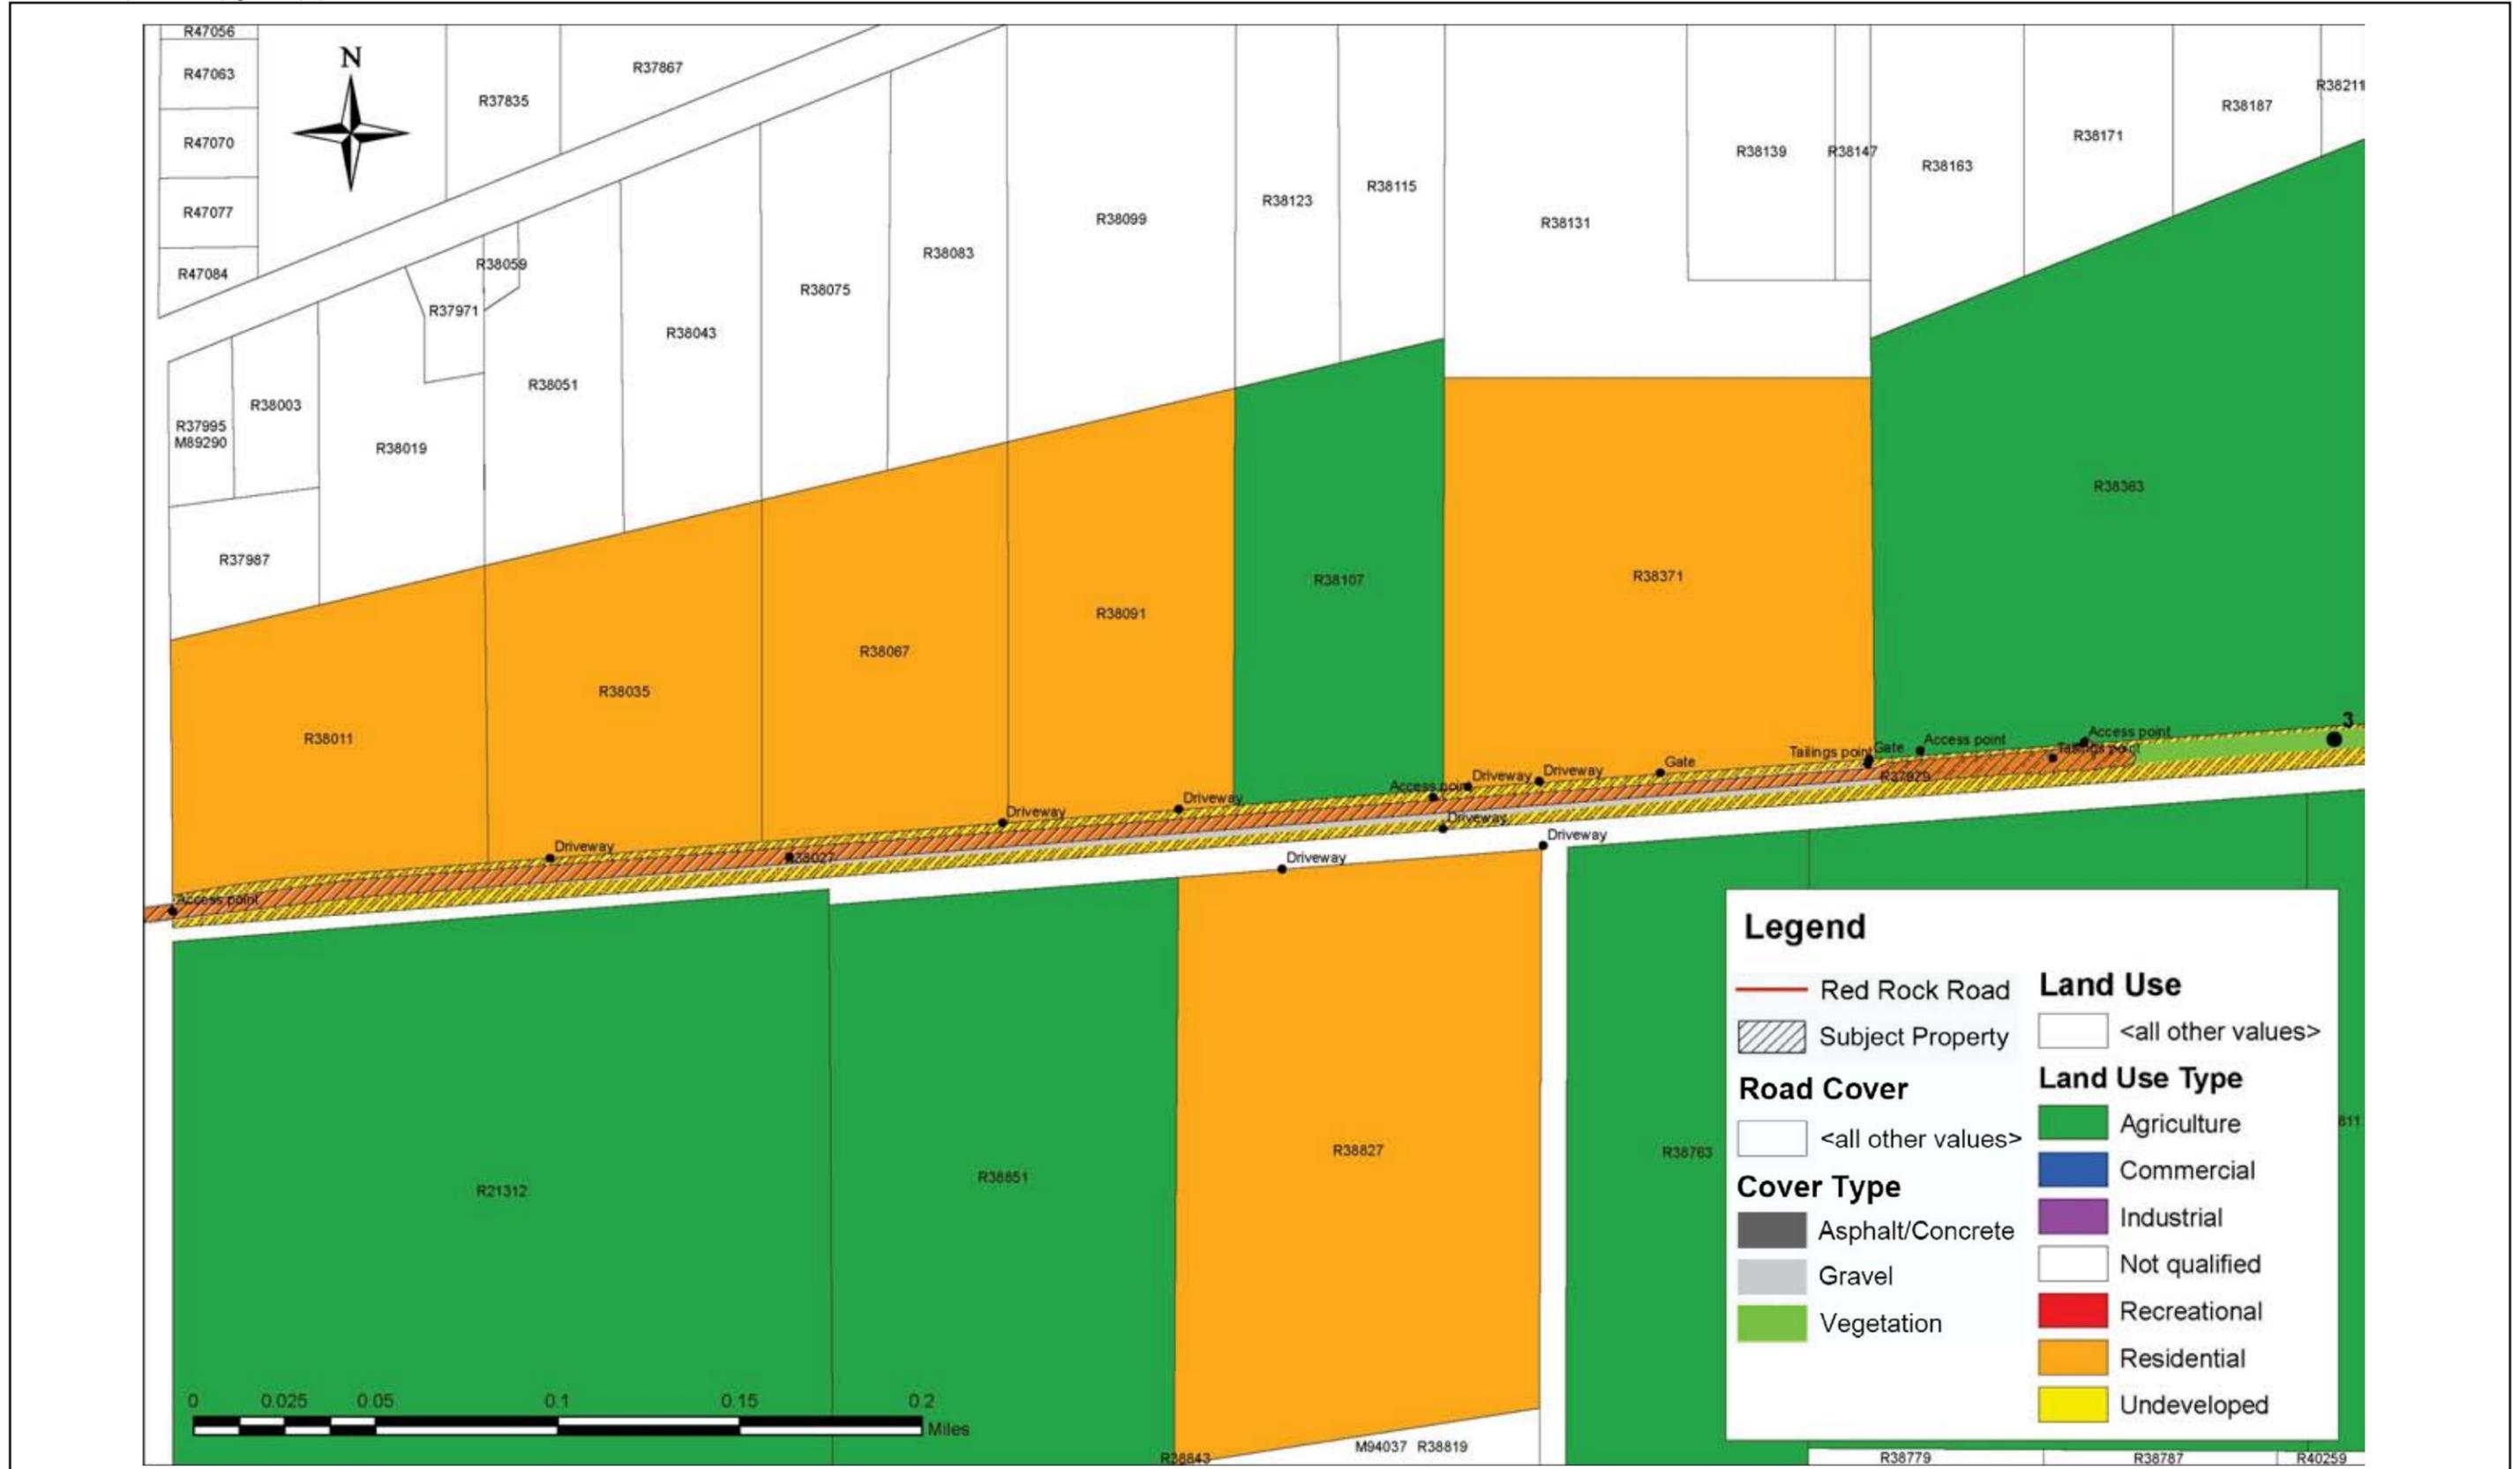
**Figure 7**  
**Map of Property #7**  
**Parcel R37979 and R38027**

The property (parcels R37979 and R38027) located east of Southside Road (Figure 7) is known as Red Road where the RRR alignment is used regularly for access to nearby residential and agricultural properties. It is covered by a densely packed layer of gravel, with tailings exposed in numerous potholes. Red Road eventually turns south and becomes Hosanna Road. At that point, the RRR alignment continues east to a locked gate, where tailings are exposed. Past the gate, RRR appears to be used for farm equipment access.

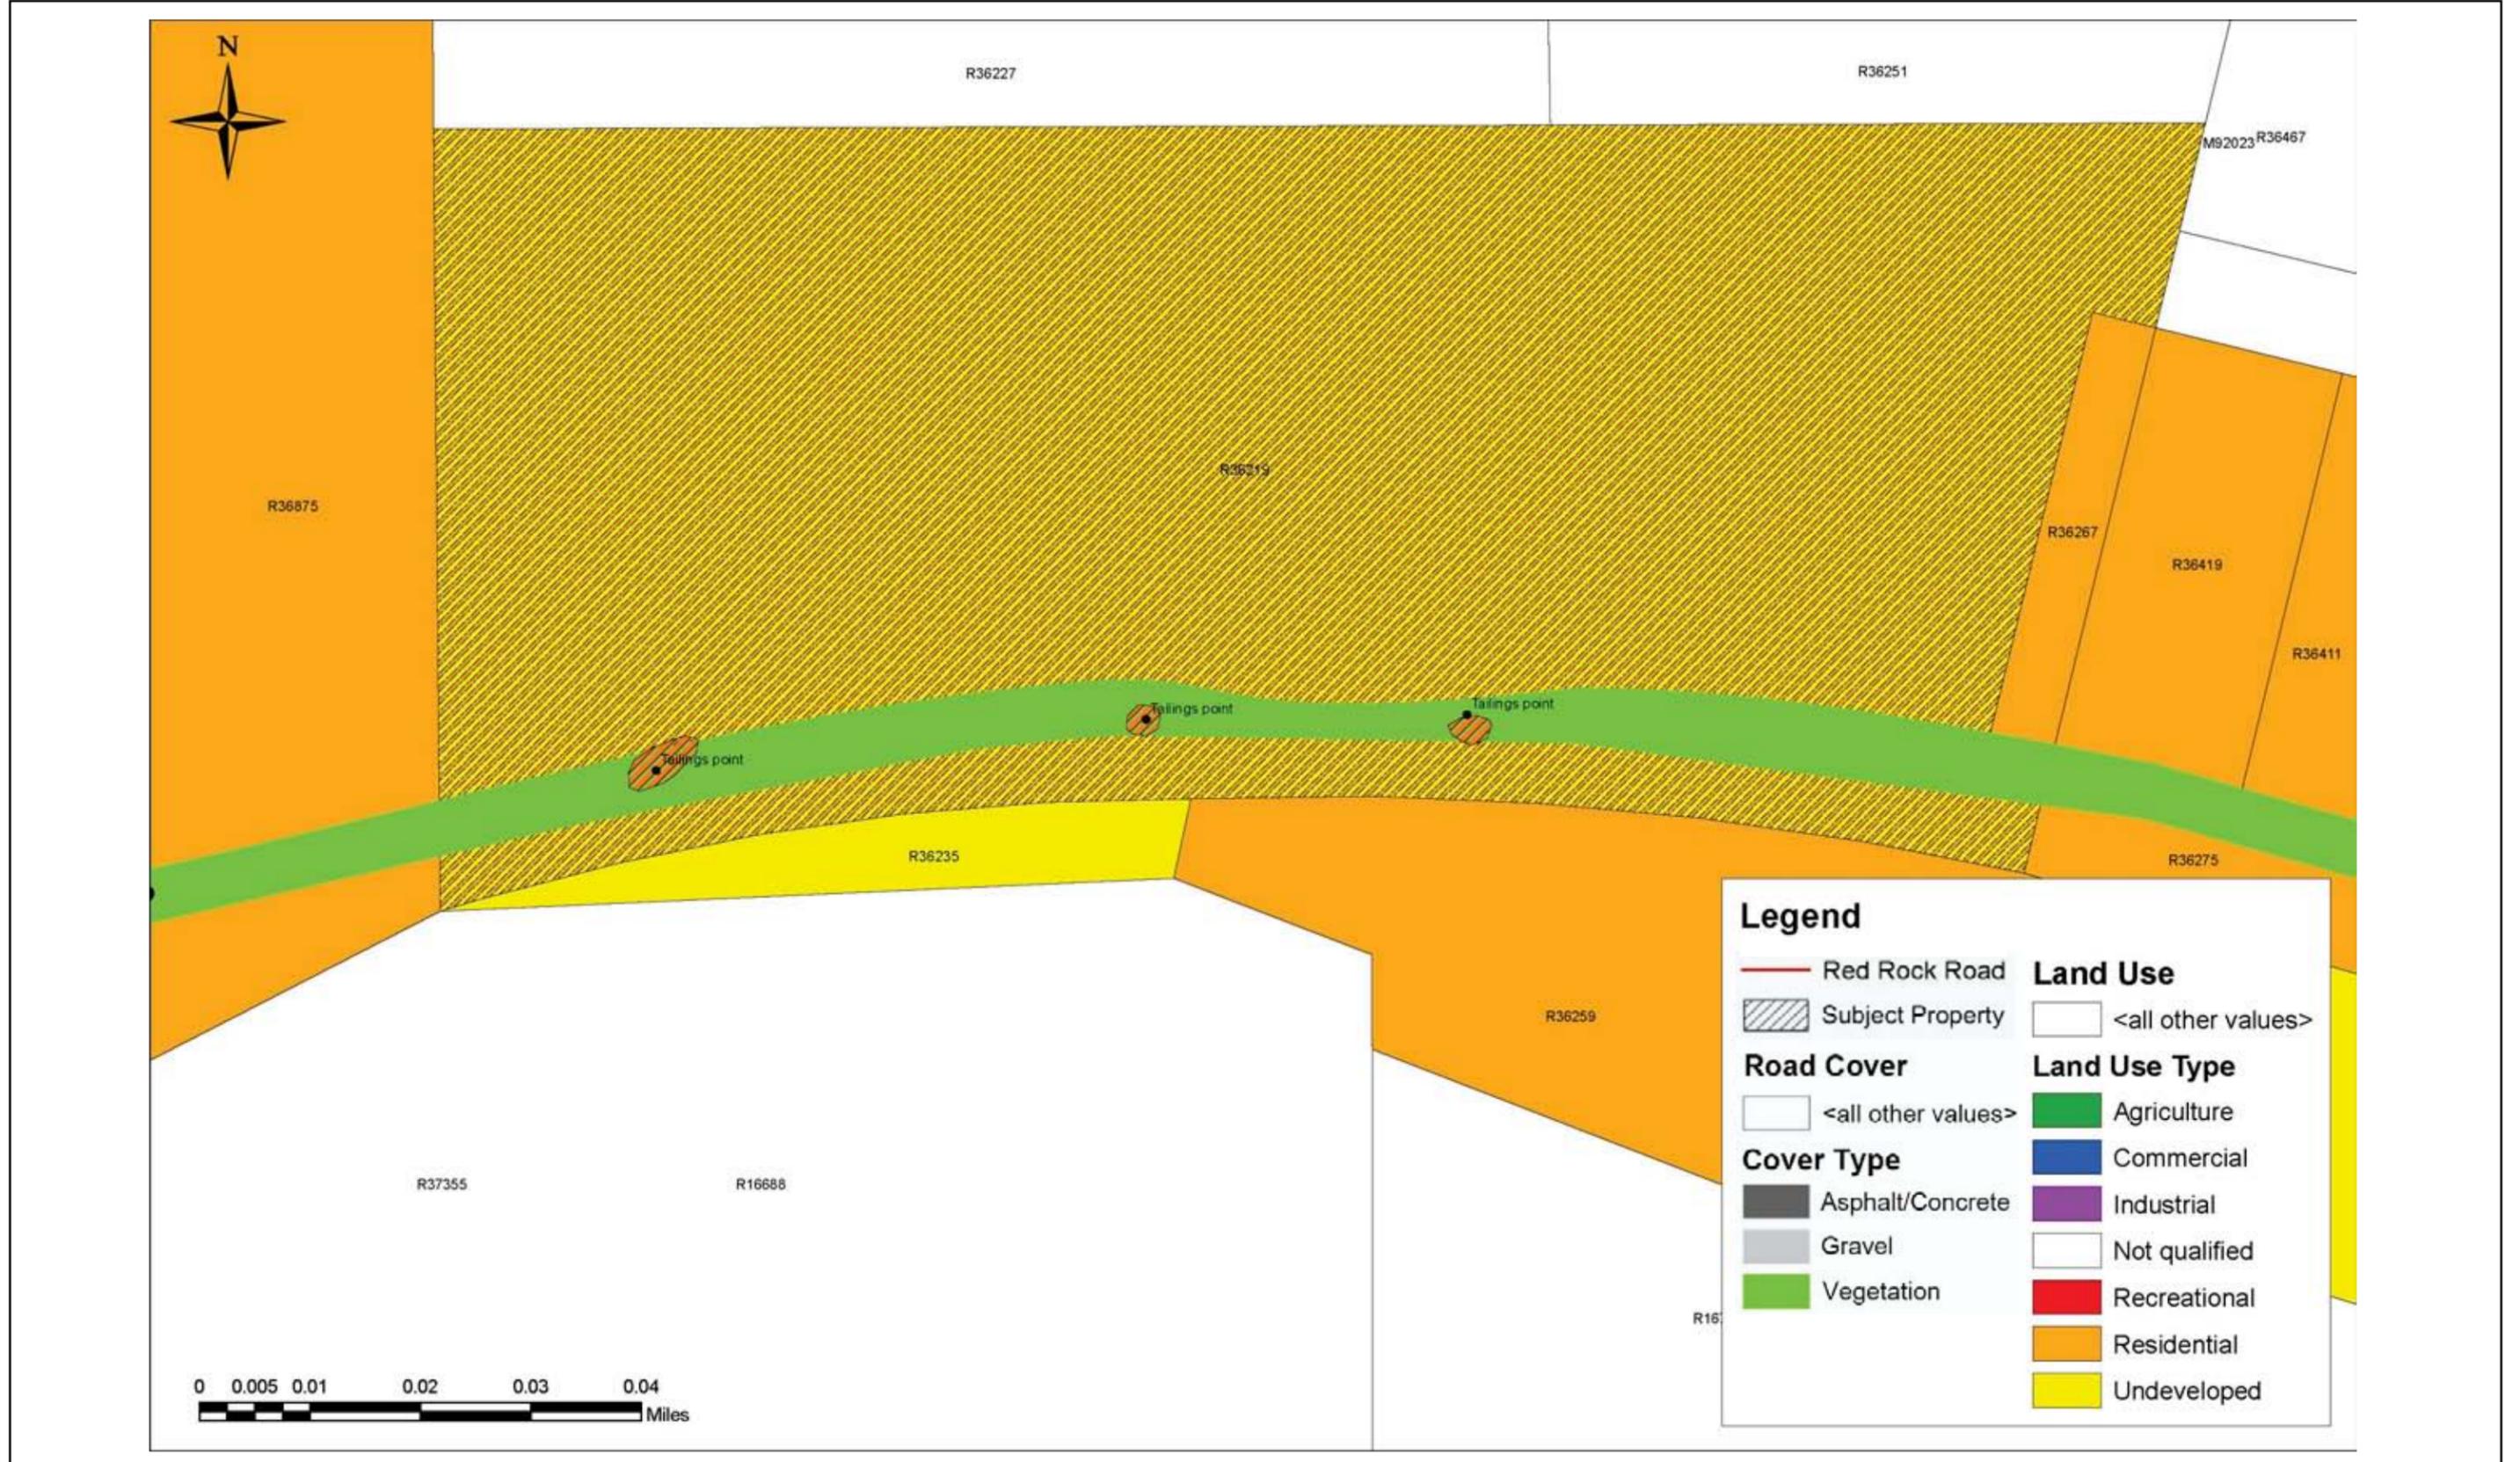
**Figure 8**  
**Property #5**  
**Parcel R36219**

This property (Parcel R36219) is approximately 6 miles east of Sutherlin on Nonpareil Road (Figure 8). The parcel is about 6 acres in size and includes a single-family residence with a large outbuilding. Red Rock Road parallels the southern boundary of the property for about 550 feet, in an east-west direction. The condition of RRR on this parcel varies from heavily vegetated with blackberries and Scotch broom on the southwestern portion of the parcel, to patchy lawn/grass on the southeastern portion of the parcel. There is an archery range about 15 feet north of RRR in the center of the southern boundary of the parcel. Tailings are visible in portions of the lawn where grass is sparse.

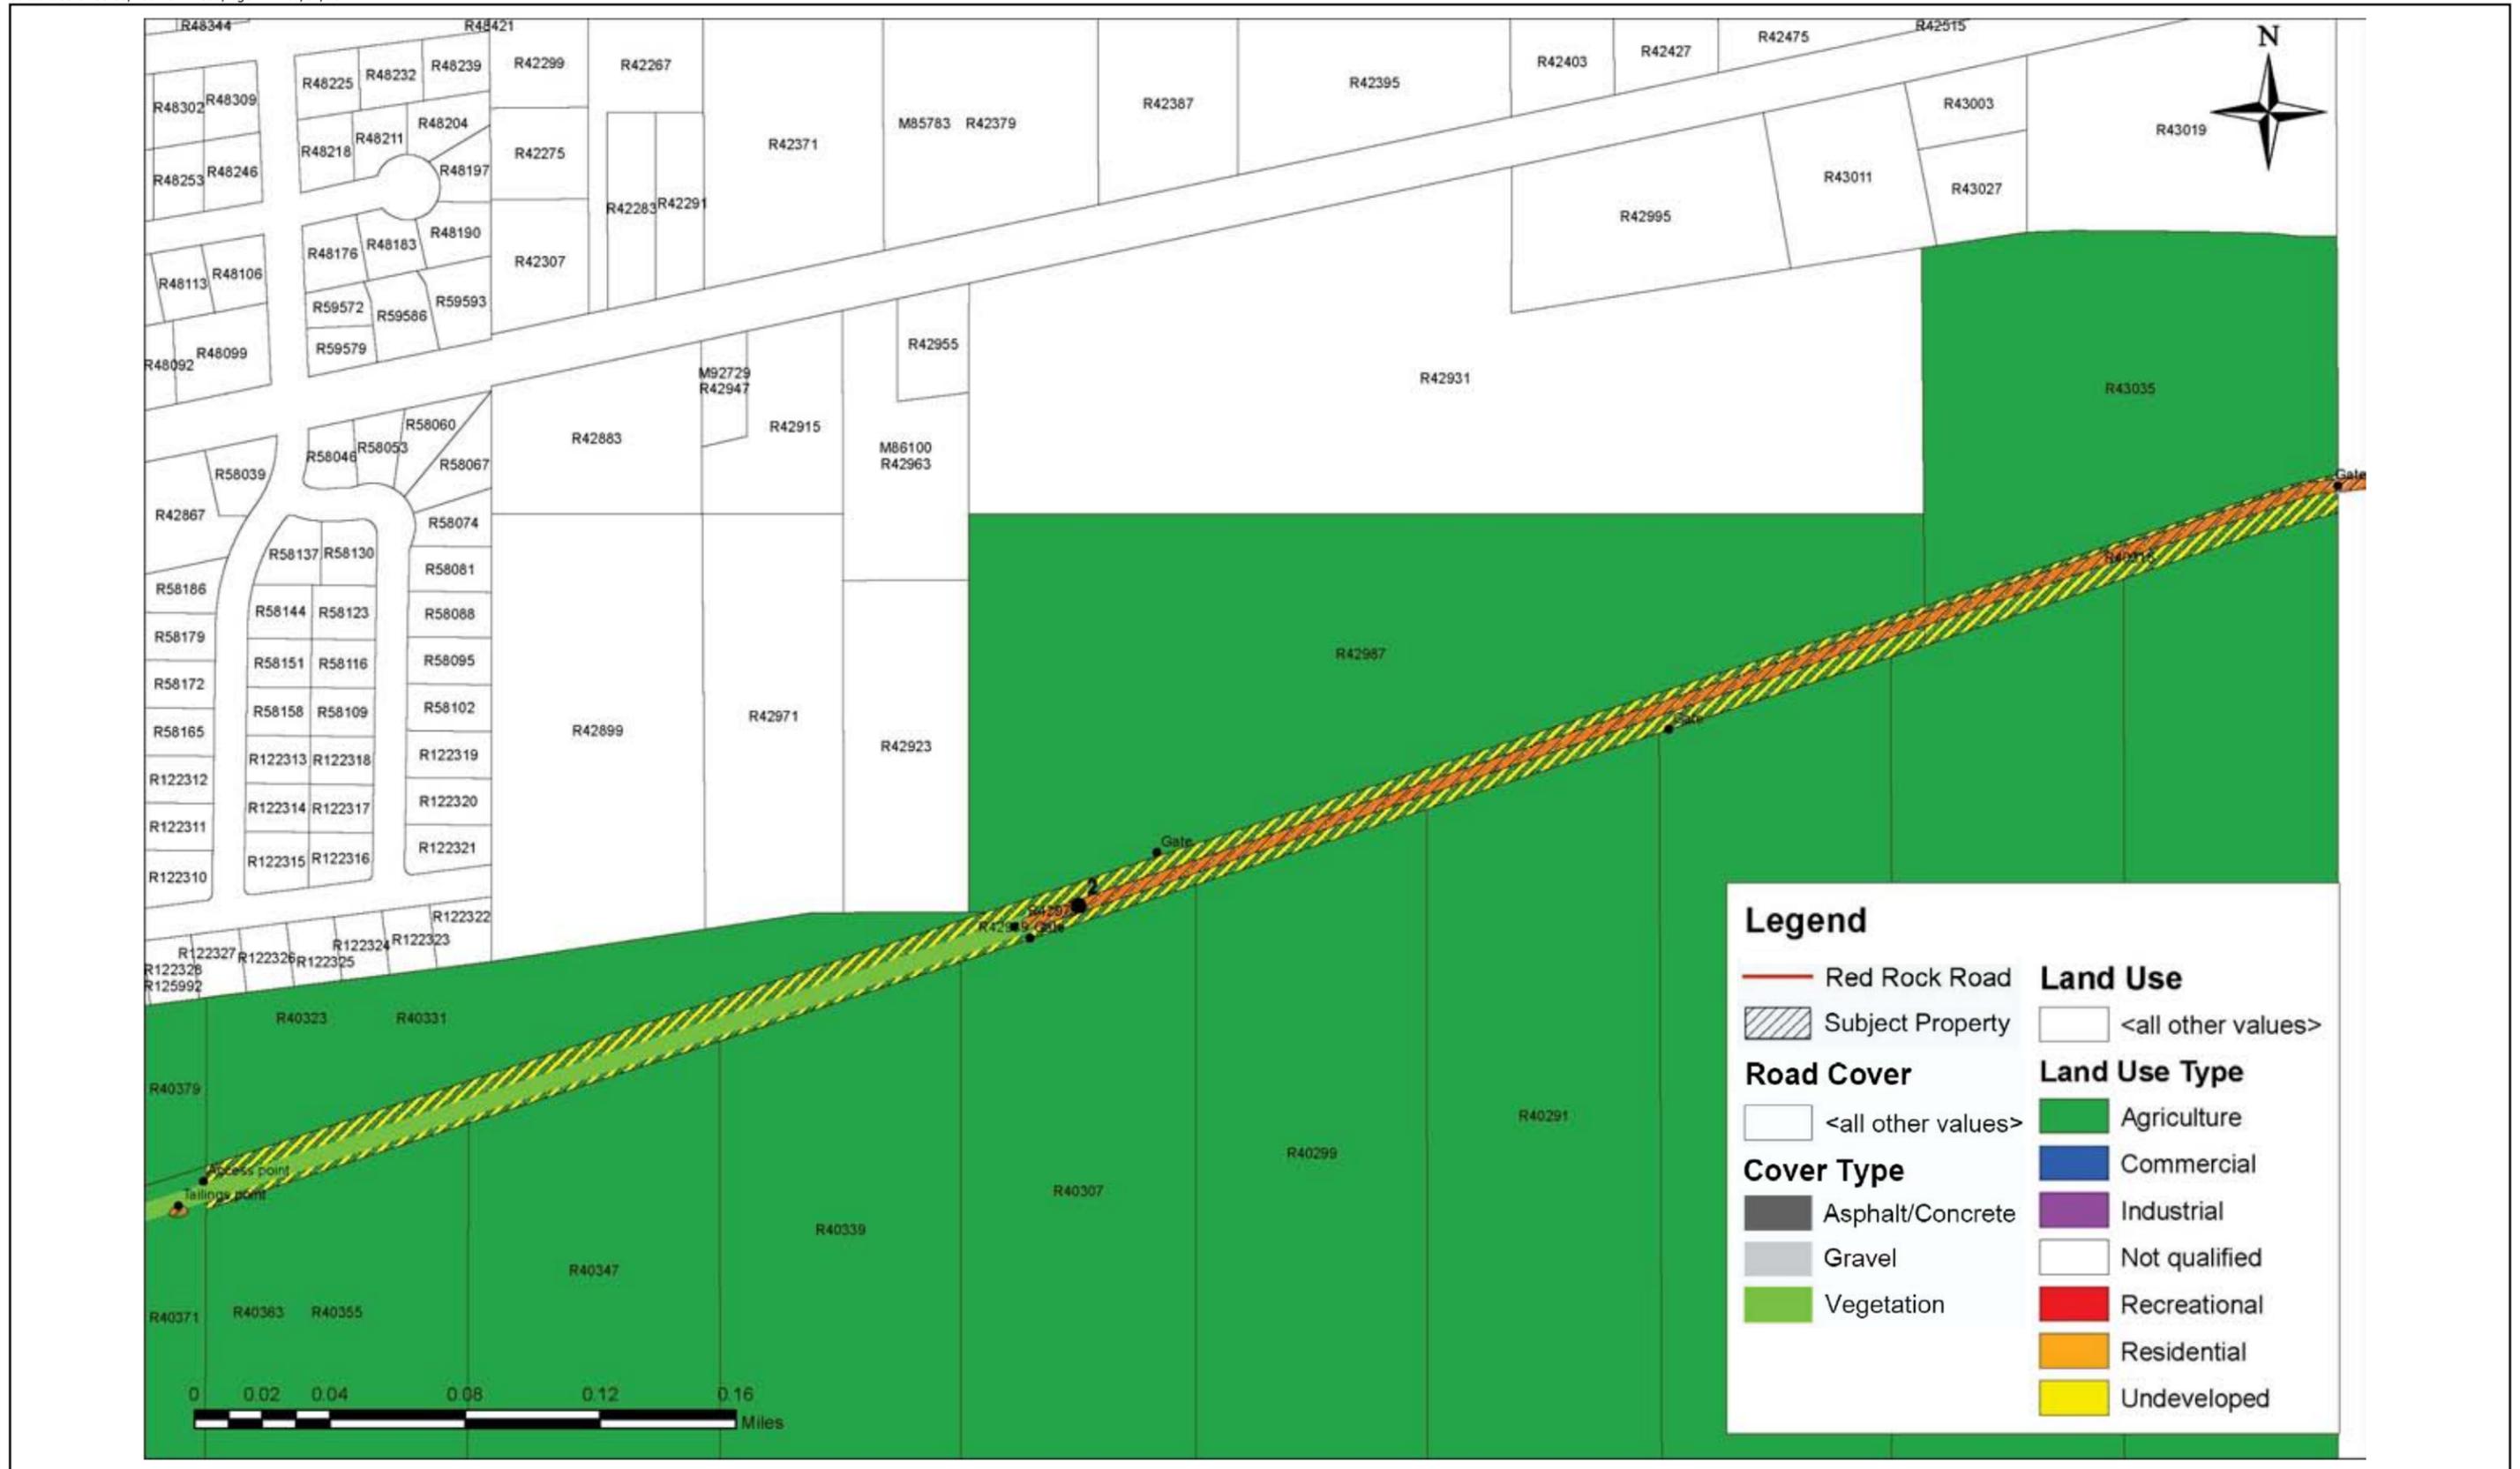
Figure 9  
Map of Property #6  
Parcel R42979 and R40315

This property (parcels R42979 and R40315) is located (Figure 9) near Southside Road. Tailings are exposed in the full length of the RRR alignment within two narrow parcels comprising this property. Red Rock Road is used to access the parcel to the north, which contains three large barns or storage structures, a garage, and a small shack. The land owners use RRR to access their shops, barns, possibly their home, and several large agricultural fields lying directly adjacent to RRR. Access to RRR from Southside Road is gated, and it appears to be used frequently for vehicular travel.
